Newcastle University, UK

Wear Analysis Report for Explanted Metal-on-Metal Hip Prosthesis

*****EXAMPLE REPORT*****

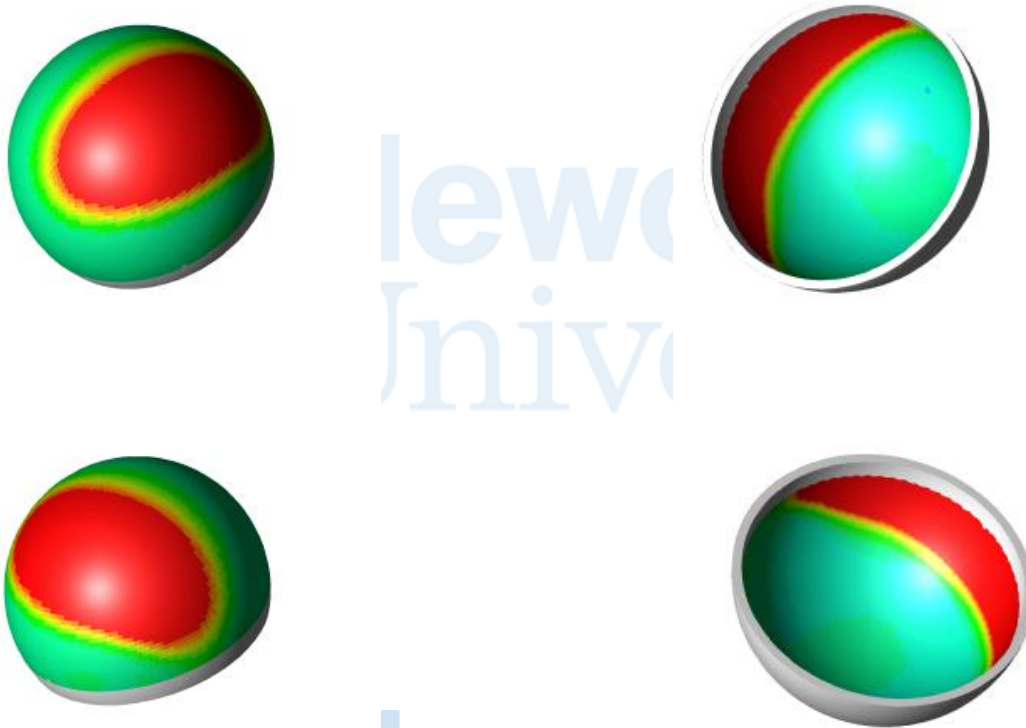
Femoral Head Wear Volume:	27.6 mm ³
Acetabular Cup Wear Volume:	64.1 mm ³
Combined Femoral and Acetabular Wear Volume:	91.7 mm ³
Average Wear Rate	22.93 mm ³ /year
Taper Wear Volume:	2.3 mm ³

For context, the average wear rate we see from the articulating surfaces of failed metal-on-metal resurfacing hips [DePuy ASR™] is approximately 18mm³/year, though importantly the range is 3.1-96mm³/year [Lord et al, Wear, 2011, 79-87]. It is our current opinion that a wear rate of 3mm³/year represents a 'tipping-point' above which failure will occur.

As shown in figure 1, both the femoral head (left) and acetabular cup (right) of the explanted ASR™ hip is heavily worn. It is likely that the high volumes of metal wear from the articulating surfaces of the femoral head and acetabular cup have been linked with clinical problems. Wear at the edge of the acetabular cup is seen and this is a common feature with failed metal-on-metal hip resurfacings. Although the taper wear volume is relatively small compared with the volume of metal released from the articulating surfaces, its effect should not be ignored. The local distribution of wear marks on the internal taper is shown in figure 2.

Figure 1 - Images of worn (red) areas on femoral head (left) and acetabular cup (right). Such 'edge wear' or 'rim wear' is commonly seen on failed, high wear acetabular components of hip resurfacings

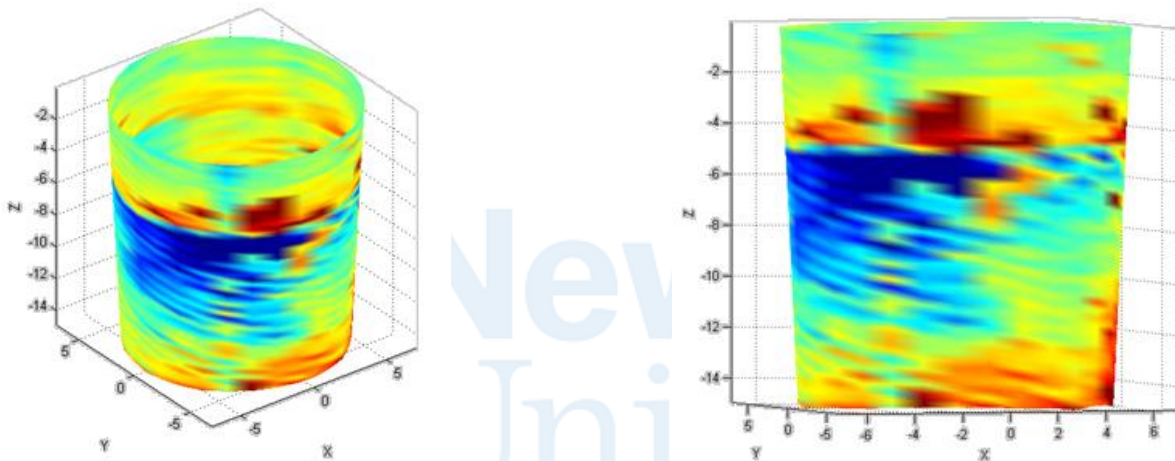
Figure 2 - Images of worn (red) areas inside taper connection of femoral head

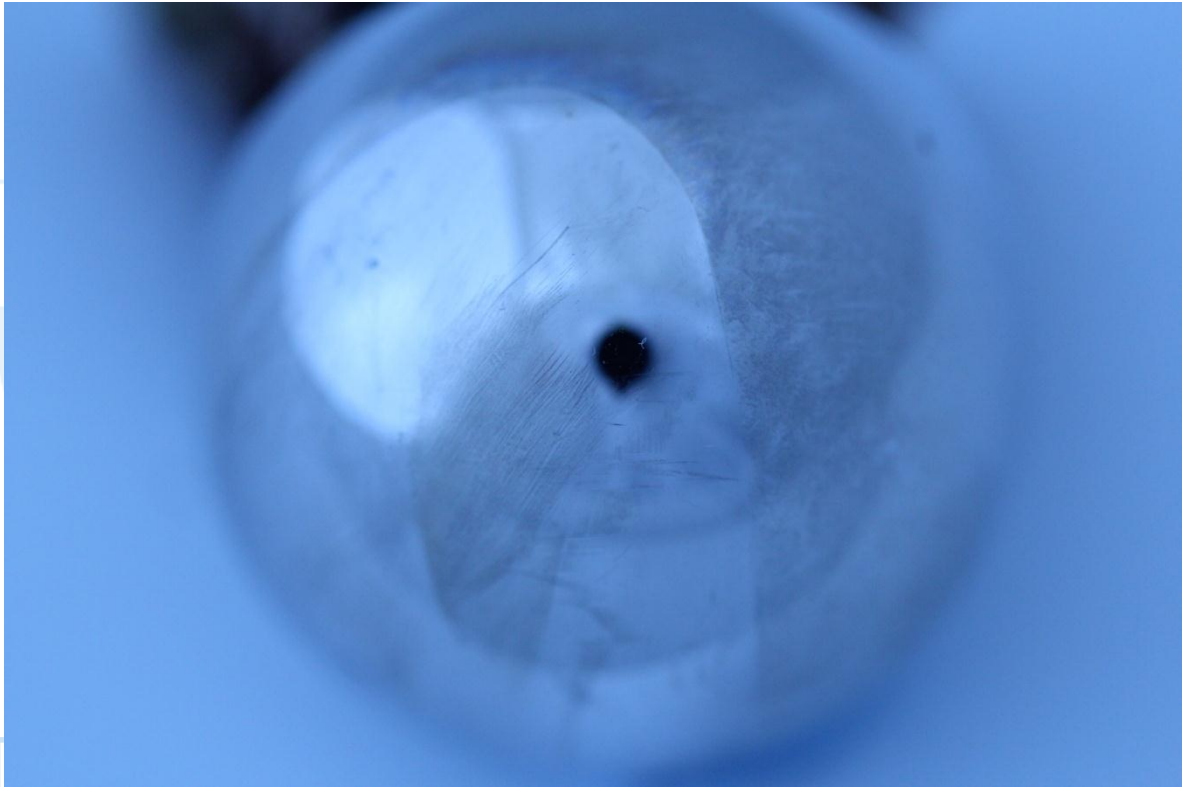
Figure 3 shows a photograph of the femoral head and the edge of the wear scar is visible by eye, as indicated by the different colour of the unworn region. Figures 4 and 6 offer images of the lot numbers of the femoral head and acetabular cup respectively, while figure 5 offers a macroscopic view of the articulating surface of the acetabular cup.

Figure 3 - Photo of femoral head showing edge of wear scar (discoloured surface to right and above)

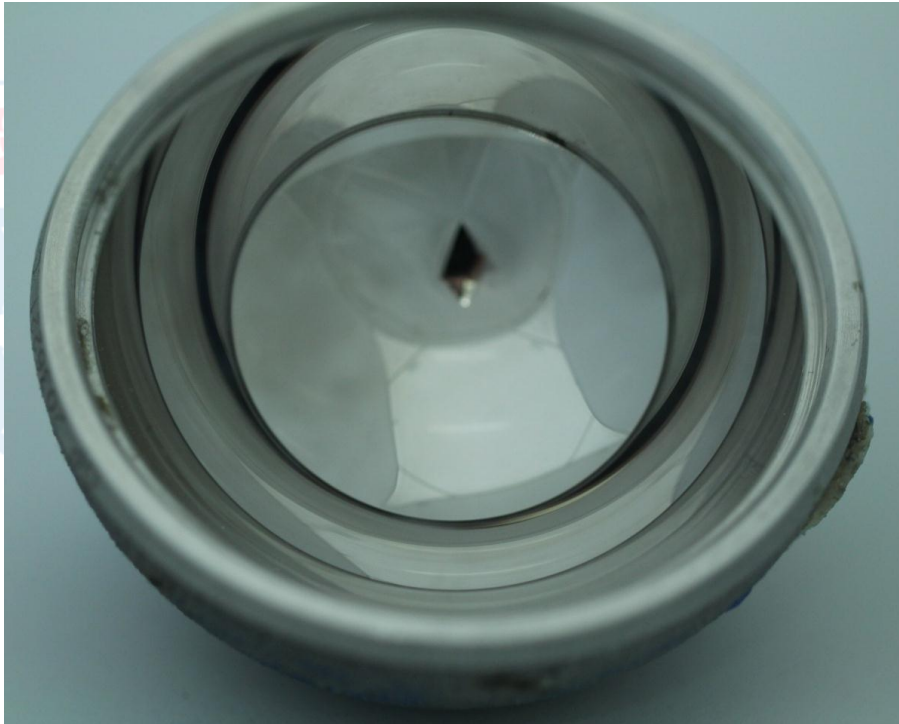
Figure 5 - Photo showing inside of the acetabular cup
