Newcastle University, UK

Wear Analysis Report for Explanted Metal-on-Metal Hip Prosthesis

*****EXAMPLE REPORT*****

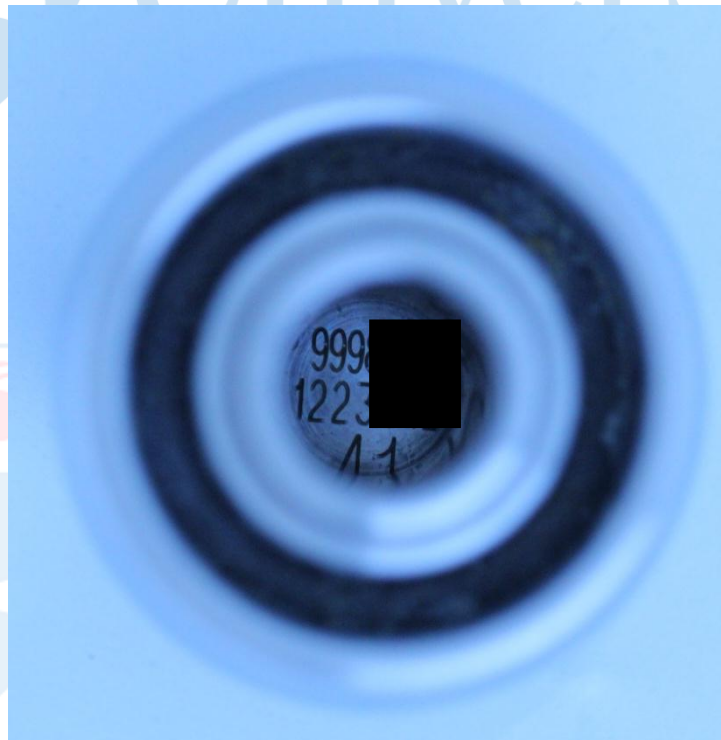
Figure 4 - Photo showing femoral head lot number

Figure 3 shows a photograph of the femoral head and the edge of the wear scar is visible by eye, as indicated by the different colour of the unworn region. Figures 4 and 6 offer images of the lot numbers of the femoral head and acetabular cup respectively, while figure 5 offers a macroscopic view of the articulating surface of the acetabular cup.
